**Re: Missouri Electric Works Facility
Trip Report
EPA Work Assignment No. 43-7W6R
Jacobs Project No. 10-D243-01**

**ALTERNATIVE REMEDIAL
CONTRACTS STRATEGY
REGIONS VI, VII & VIII**

**TRIP REPORT
FOR
JANUARY 28, 1991 TO MARCH 1, 1991
MISSOURI ELECTRIC WORKS FACILITY
CAPE GIRARDEAU, MISSOURI**

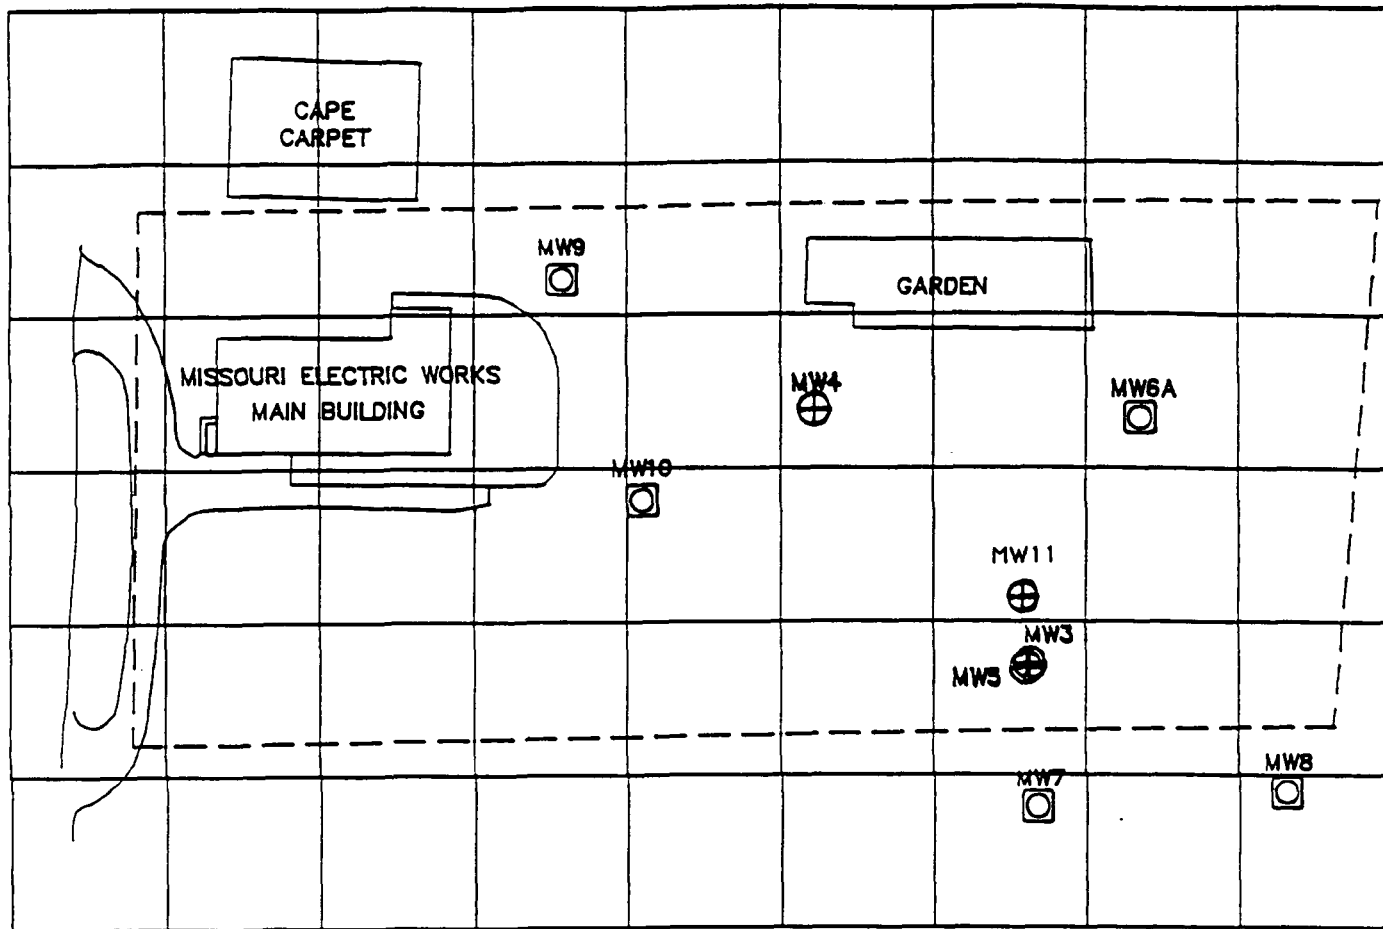
The monitoring well, (MW-11), was constructed by John Mathes and Associates, Inc. under the direct supervision of TETC personnel. The location of this monitoring well is depicted in Figure 1. A total of four boreholes were drilled in an attempt to install a monitoring well to a depth of 180 feet. The initial borehole was drilled to a depth of 142 feet, with continuous rock coring from 60-142 feet. This borehole was abandoned after the core barrel became lodged in the borehole and could not be removed. Two other boreholes were also initiated and later were abandoned due to complications encountered during drilling. A monitoring well was finally installed at the fourth borehole location. A CME-95 drilling rig equipped with hollow stem auger, rock corer with NX diamond-impregnated core barrel, and an air compressor for air coring was used in the operation. A VAN AIR CX series coalescing filter was used to remove hydrocarbons and volatiles in the compressed air line. Drill cuttings were shoveled to the side of the drill rig.

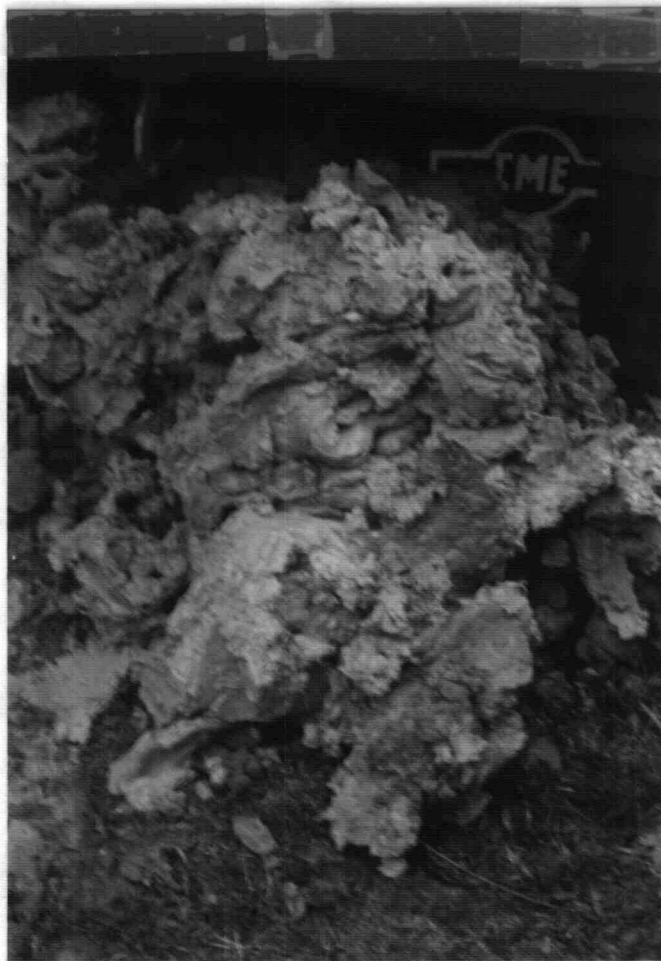
PHOTOGRAPH NO. 2

At 0824 the Mathes personnel began advancing the boring. At 0859 the drillers notified Mr. Trometer that drill cuttings were going to be spread out on the ground on MEW property. Photograph 2 gives a pictorial description of the drill cuttings. At 0921 competent bedrock was encountered at approximately 60 feet. The drillers tripped out of the hole once the competent bedrock surface was encountered. Hoses were then placed in the borehole and the grout mixture was pumped into the borehole. Upon completion of grouting the boring, Mathes personnel lowered steel outer casing into the borehole. Casing of the boring was completed at 1231. At 1445 ARCS representatives, Mr. Todd Trometer and Mr. Bill Gresham, met with Jim Fels and Kurt Hollman of the Missouri Department of Natural Resources to discuss field activities. At 1616 TETC personnel began taking water level measurements from all remedial investigation (RI) monitoring wells with a Solinst water level indicator. Table 1 gives the water level elevations along with the measured depth of each monitoring well. New onsite personnel included:

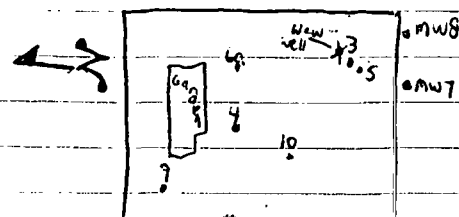
1130 Received map of well locations. Here is a schematic of these locations.
